SBS BUILDING *fka National Old Line Insurance Building*

Building Location: Capital Avenue Little Rock, Arkansas

Date of Site Visit: 9/06/06

Field Notes, Background & General Observations

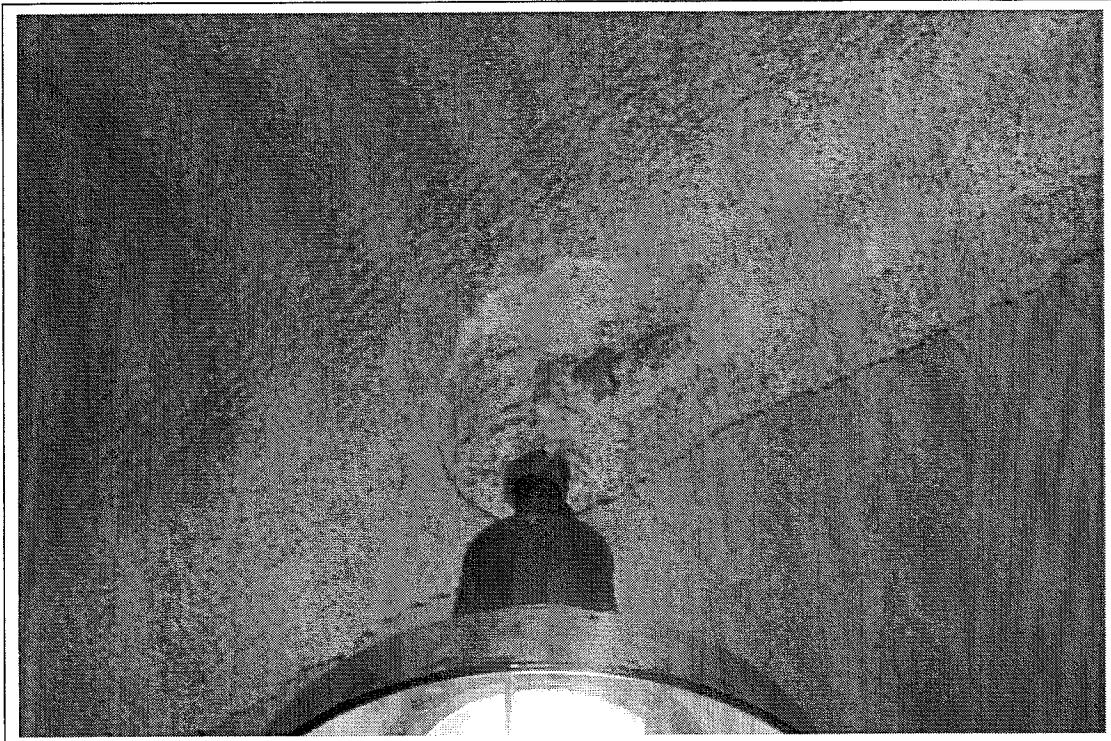
Photo 5. paint shop – delamination of fireproofing at light fixture

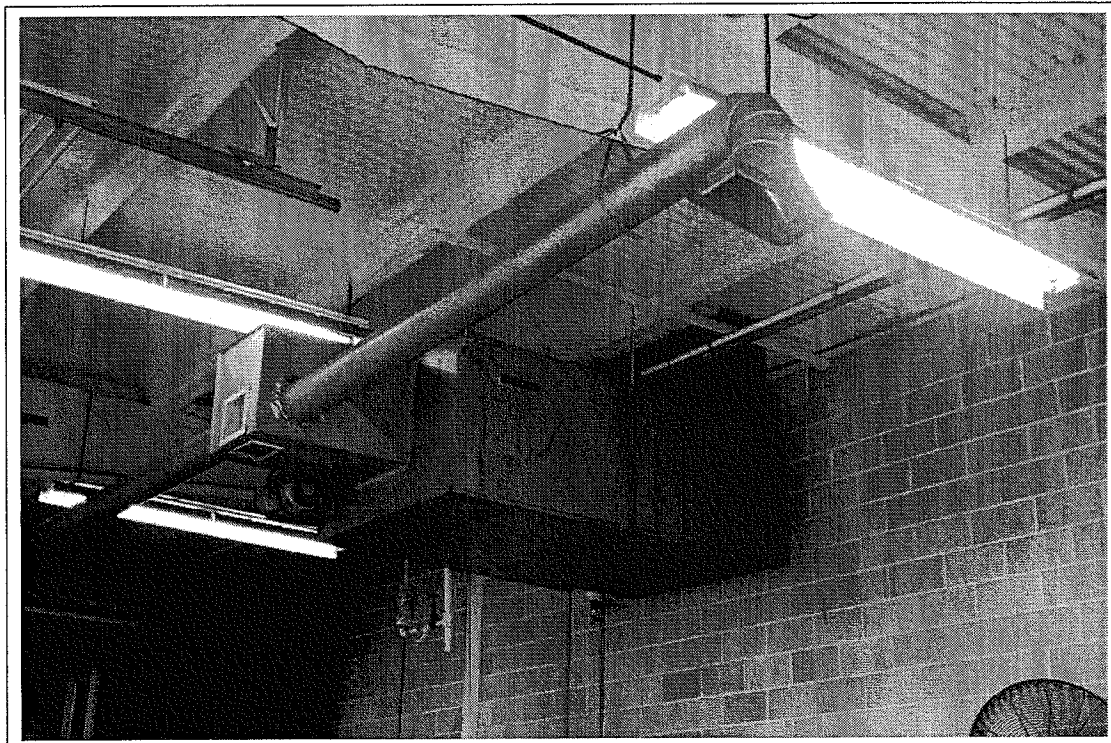
Photo 6. garage – deck hung HVAC unit below fireproofed deck

Influence of Vibration: Low – in most areas of the South tower and center wing primarily from supplemental HVAC units hung from the fireproofed decking in sporadic areas. High – in the basement mechanical areas.

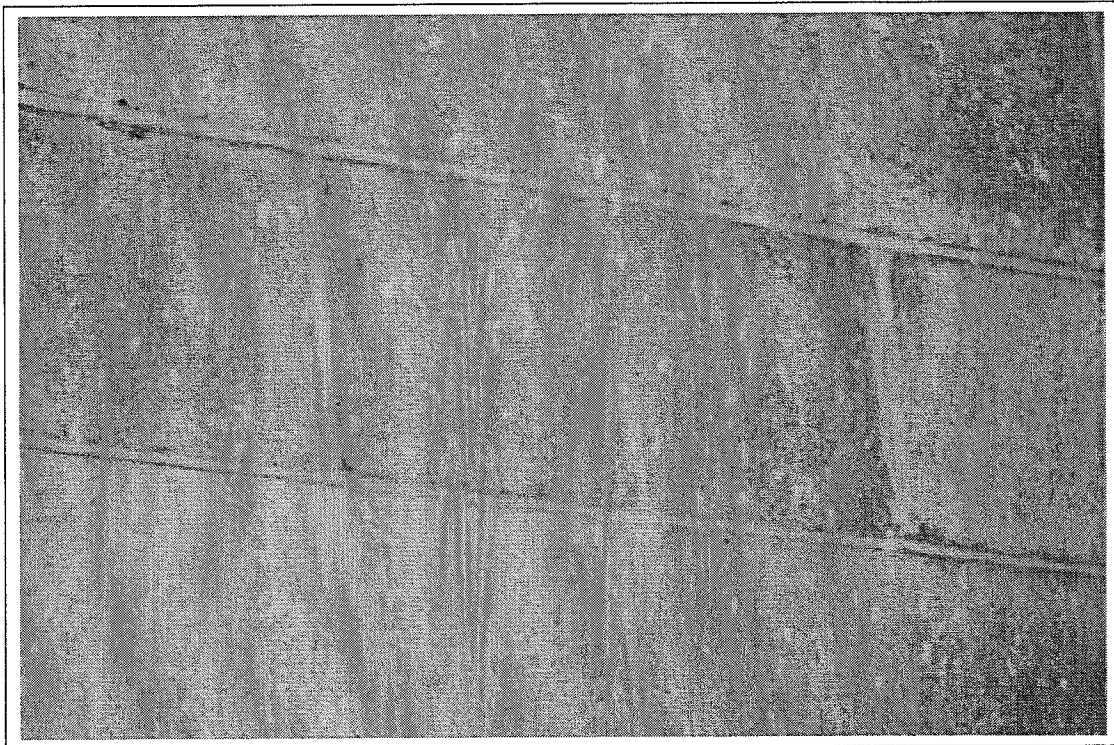
Photo 7. rear hall – close-up of fireproofing overspray on concrete block wall

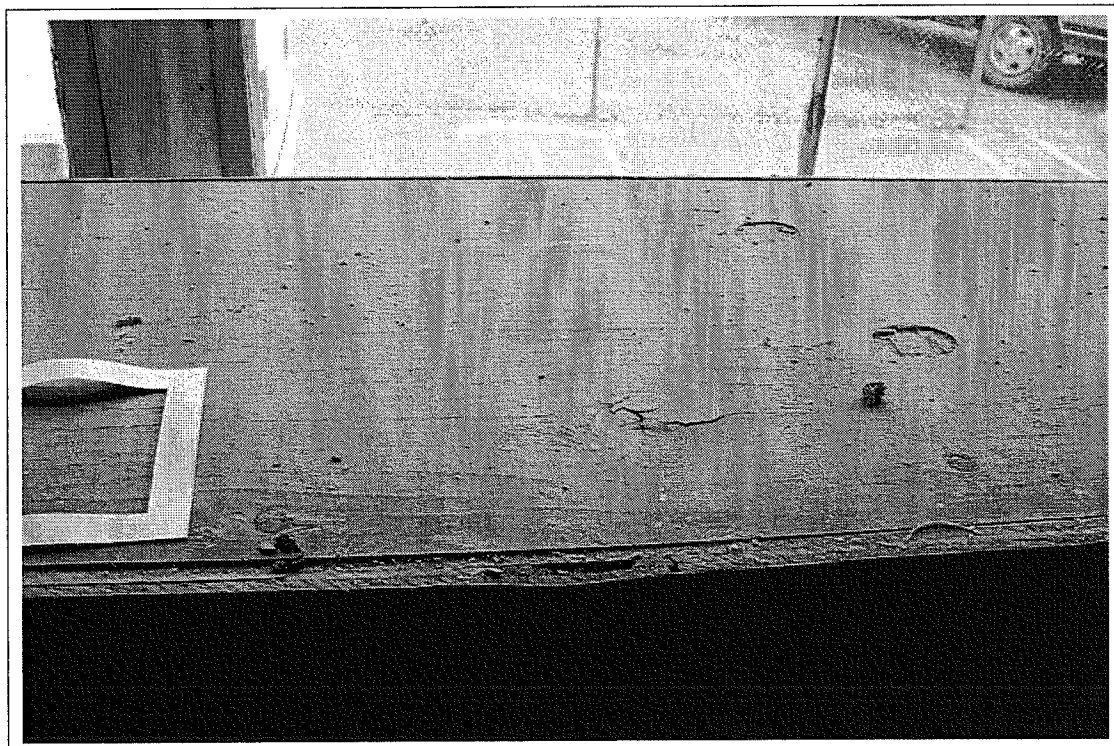
Photo 8. paint shop – top of storage cabinet after dust sampling (sample # 3)

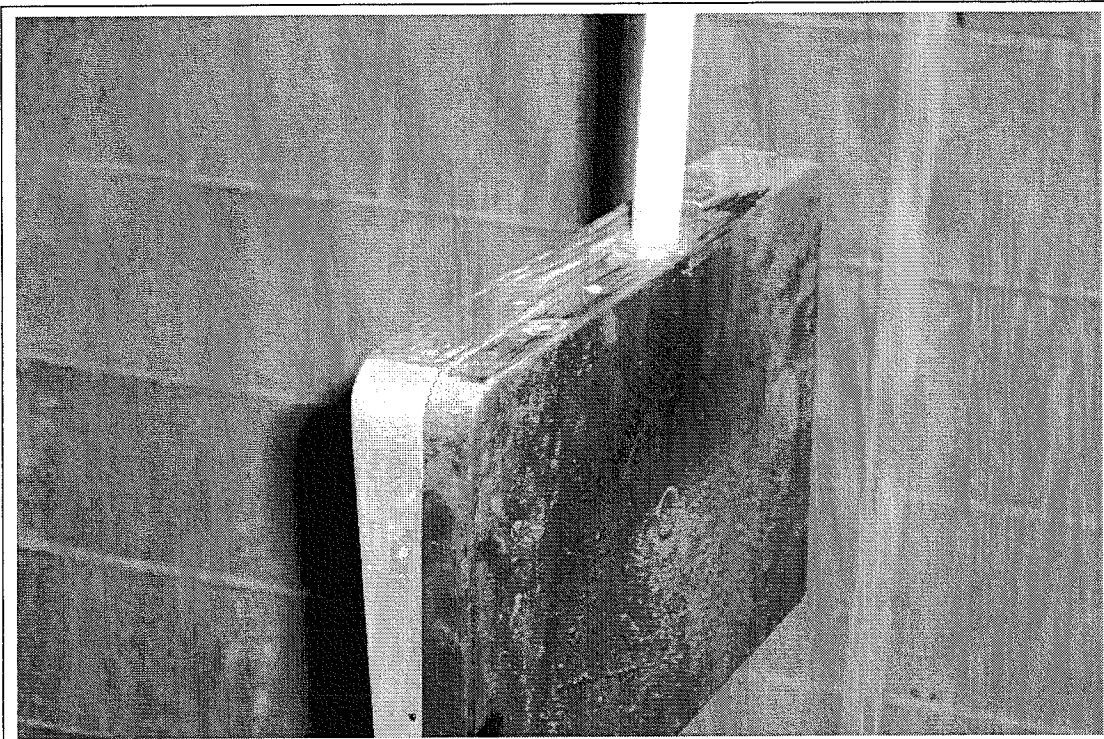
Photo 9. rear hall – top of exit sign after dust sampling (Dust Sample #1)

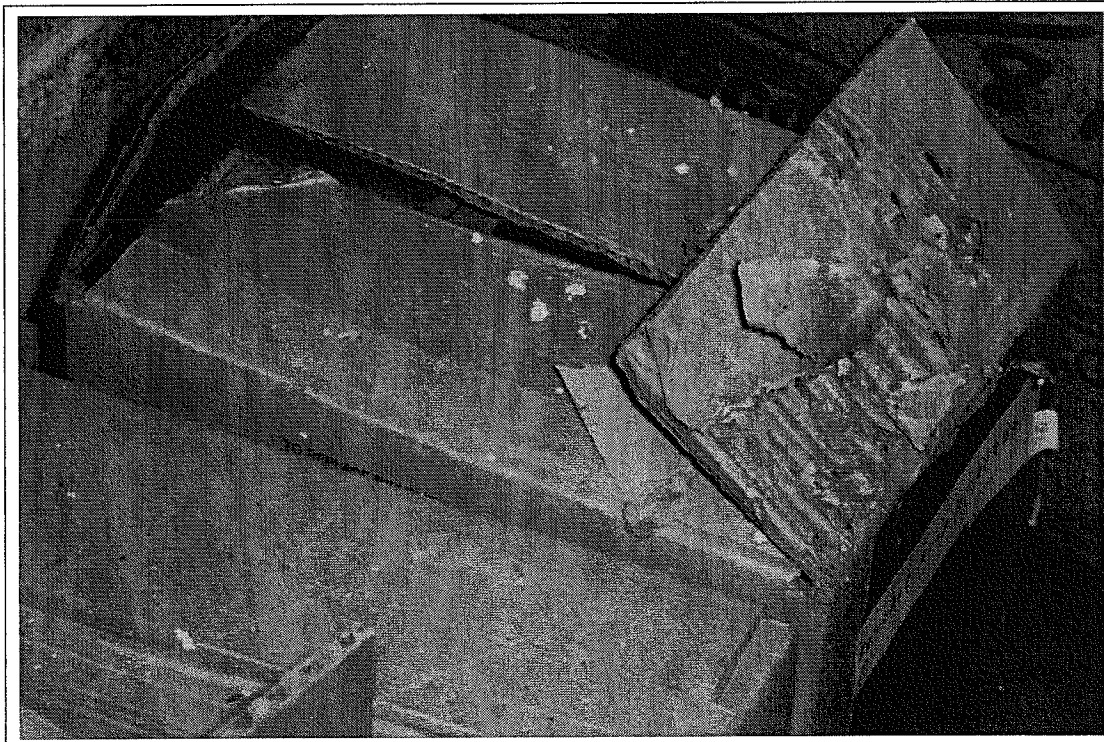
Photo 10. parts/stockroom – delaminated fireproofing dust and debris on top of boxes
